IMPACT RECOVERY SYSTEMS  
 PED-IN-A-BAG™ CRASH TEST REPORT  
 MARCH 2012

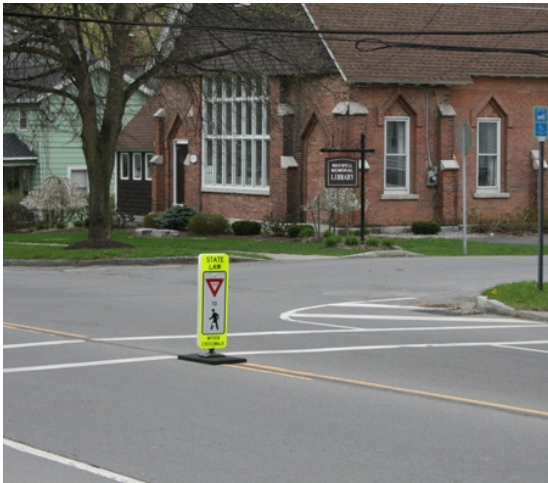
Product tested was a standard Ped-in-a-Bag™ Pedestrian sign, 12” x 36” with a standard yellow 110 spring assembly. Base used was a 20 pound lightweight portable. Sample is representative of a standard production model, although sheeting applied was obsolete but deemed to have no impact on crash testing mechanical results.

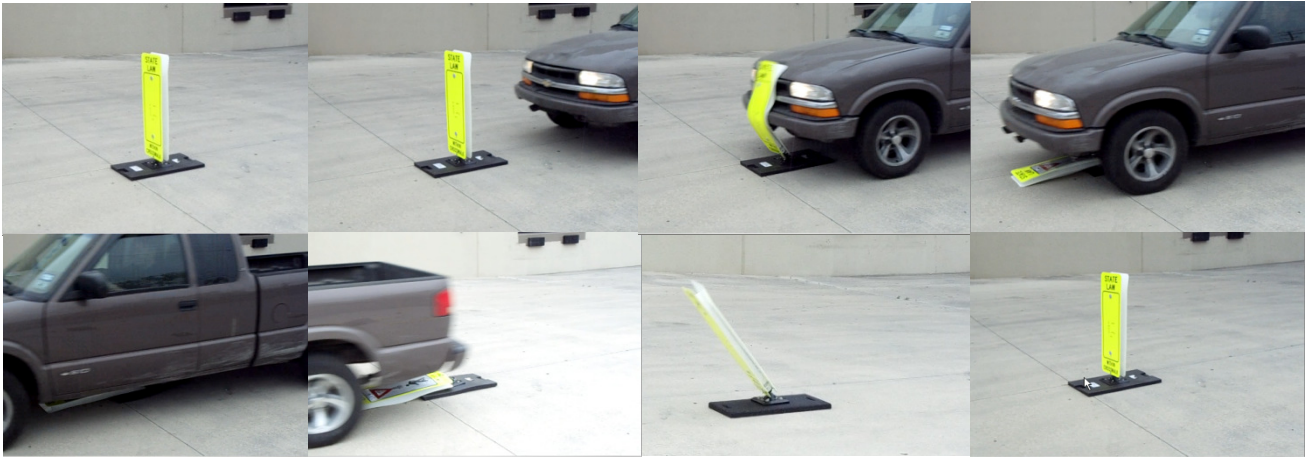
Below is a representation of a 20 mph bumper strike:

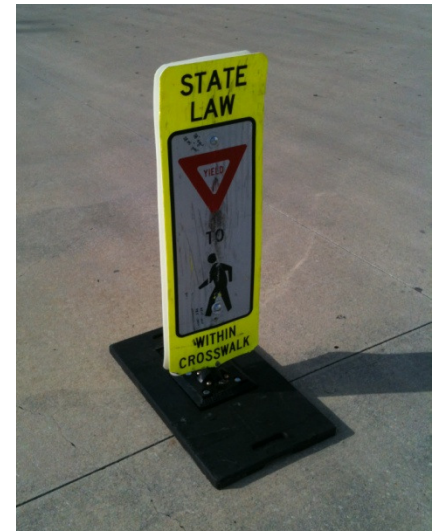
Figure 1 - Through 14 Impacts

Initial testing through 14 impacts was at or below design criterion. The sign exhibited the expected results, giving upon impact and returning upright. Several times re-positioning of the base was required to continue.

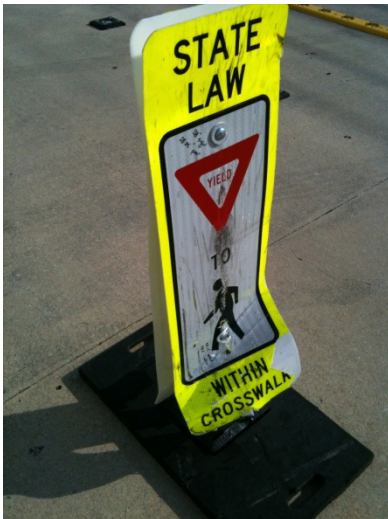
Figure 2 - Through 18 Impacts

Impacts 15-18 were more extreme, including one 25 mph strike and an off-angle strike. Damage to the lower portion of the sign can be seen in Figure 2. The spring mechanism and base are fully functional, however.

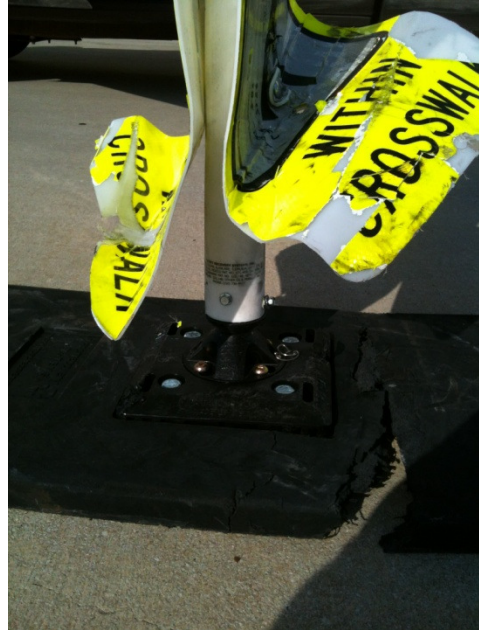
Figure 3 - Tested to Failure Mode

Final testing was intended to produce a failure of the product to determine failure modes. Strikes above 20 mph induced base drag beneath the vehicle. Also, previous damage to the lower sheeting was exacerbated.

Final failure was caused by a catching of the base under the bottom of the vehicle. Although the sign would continue to serve its purpose, it would no longer behave as intended upon impact. Spring and post mechanisms were intact.
